A Case Study of Debris Flow Hazards in the Bayi Gully, Sichuan Province, China

Case Study

Many debris flow hazards were triggered in Earthquake area after the Wenchuan Earthquake. On 13 Aug.2010, a catastrophic debris flows were triggered by heavy rainfall in Bayi Gully, Dujiangyan county, southwestern china. This debris flows originating shortly after a rainstorm with an intensity of 75 mm/h transported a total volume of more than $116.5 \times 10^4 \text{ m}^3$. Our primary objective for this study was to analyze the characteristics of the triggering rainfall and the debris supply conditions, and to estimate debris flow volume, mean velocity, and discharge. The debris flow destroyed the most downstream dam in the catchment during a heavy rain storm. The debris flow with a peak discharge of $1082 \text{ m}^3/\text{s}$, a total volume of 1.16 million cubic meter, a density of $1.88 \text{ g}\cdot\text{cm}^{-3}$ and a yield stress of 6700 Pa caused 2 persons were missing, 1 persons were injured and 140 houses buried. After three rainy seasons, Only 30% sediment of debris deposition was taken away by 4 large-scale debris flow events. New debris flow will be triggered by rainfall in

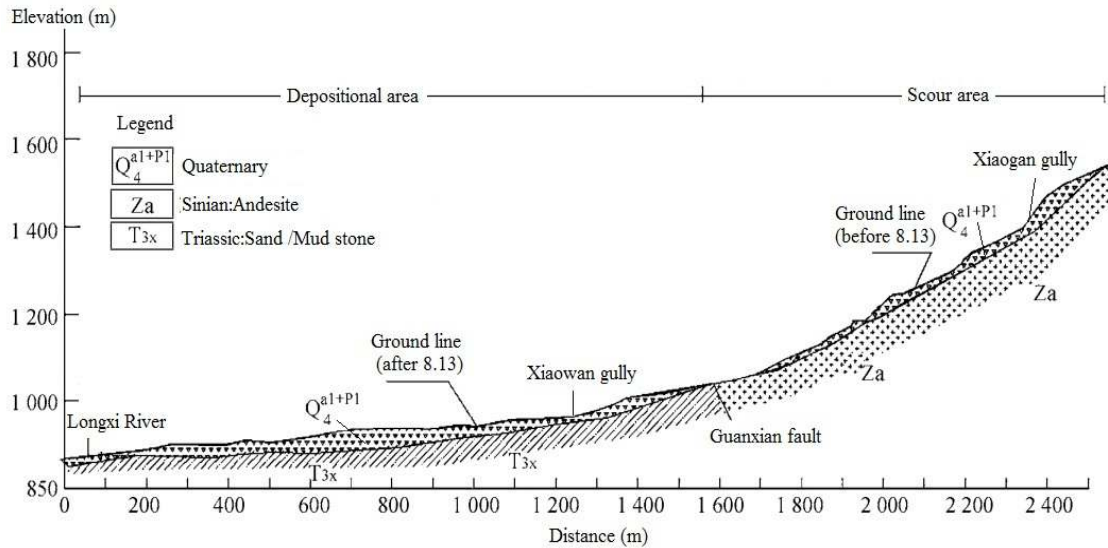
Fig. 4. Cross section of the debris flow in the Bayi Gully

Bayi Gully lies southwest of Longchi Town, with a catchment area of 8.63 km² and a 4.45 km long in the main channel. the gully mouth lies at an altitude of 850 m and the highest peak at an altitude 2456 m resulting in a difference in elevation of 1606 m. The average longitudinal gradient of the channel is 376.7‰. in the drainage area, The steep hillside slopes, deeply cutting-in canyons, short channels, and a v-shaped transect of channel of the Bayi Gully has steep side walls that provides suitable topographic conditions for debris flow outbreaks (shown in Figs. 2, 3, 4).

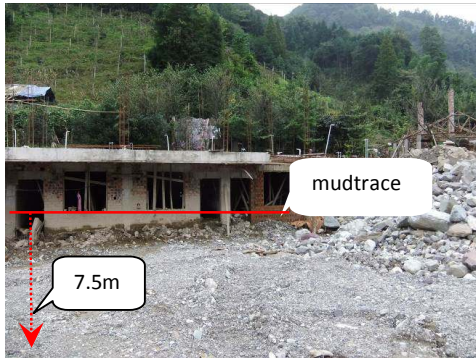
channel was 112‰, and of $86.4 \times 10^4 \text{ m}^3$ total debris flow volume. Some houses are seriously destroyed and silted in Jianjiansh, the minimum depth of deposit is estimated to be 7.5 m (shown in Fig. 5). The particle sizes of coarsen layer were decreasing from upper to lower (shown in Fig. 6).

Fig. 5. Houses was destroyed and silted in Jianjianshu

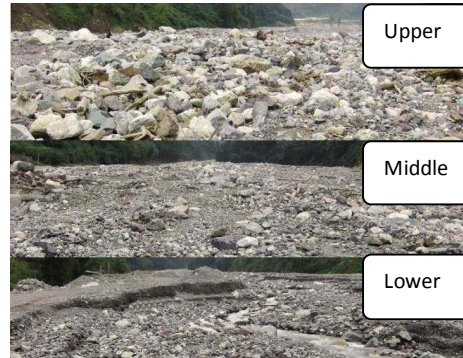
Fig. 6. Change of particle of coarsen layer in deposition zone

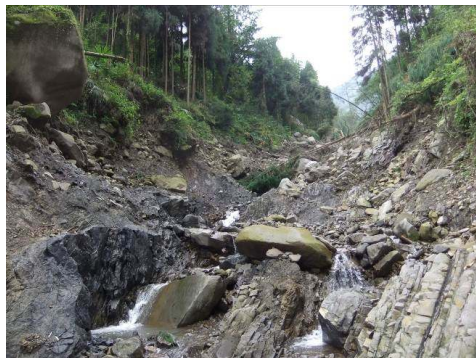
The Xiaowan gully lies at an altitude between 930 and 1714 m, with the catchment area of 2.09 km^2 . The channel is extremely narrow, most parts of which are within 3 m, with the narrowest place of 1.5m only. Fig. 7 shows that gully washing and erosion is serious, the sediment loading of watershed outlet is obviously added. Fig. 8 shows that many trees were destroyed. Therefore, it can be seen that this debris flows had great carrying capacity and destructive power. From our field observations, we suggest that the initiation of debris flows in the Xiaowan gully started with significant surface washed and ditch erosion.

Fig. 7. Washing and erosion in forming region of Xiaowan gully

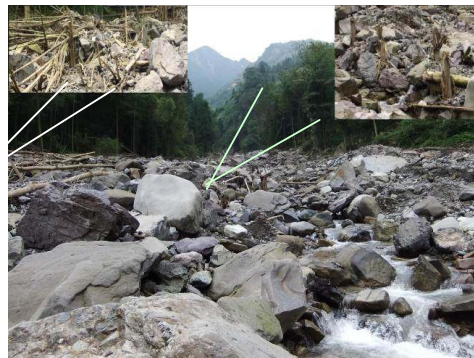
Fig. 8. Trees were destroyed in pathway region of Xiaowan gully

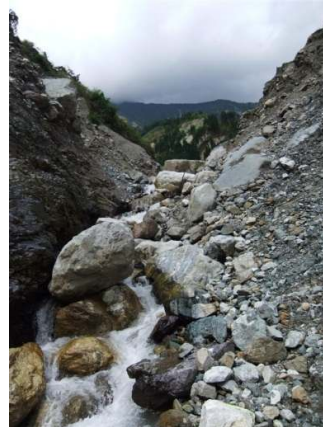
2.96 km^2 . During field investigation, the sizes of some big stones are surveyed and the largest one are up to 12 m in dimension with a weight about 320. Fig. 9 shows that highly weathered bedrock and colluviums derived from rock fall and landslides. Fig. 10 shows that new water dam derived from rock fall and other mass-wasting processes are located the source area. From the observations, we concluded the debris flows were initiated by water runoff from colluviums at the foot of a steep slope in the Xiaogan gully.

Fig. 10. New water dam in Xiaogan gully

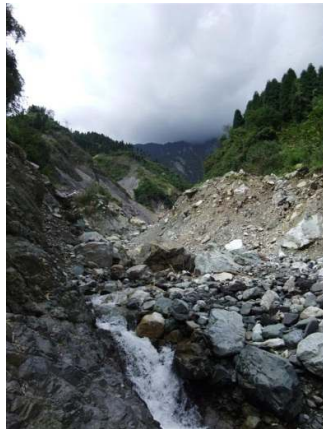
The Dagan gully lies at an altitude between 1072 and 2436 m, with the catchment area of 2.62 km^2 . The main Characteristic is blockage. Fig. 11 shows that debris flow left the accumulation body along the sides of the channel after the blocking body was busted. Fig. 12 shows that new rockfill dam, from the observations, we concluded the debris flows were initiated by heavy rainfalls and floods broke these dams derived from landslides block channel, formed strong flows, eroded the bed of the channel in the Dagan gully.

Fig. 11. Lateral dyke in Dagan gully

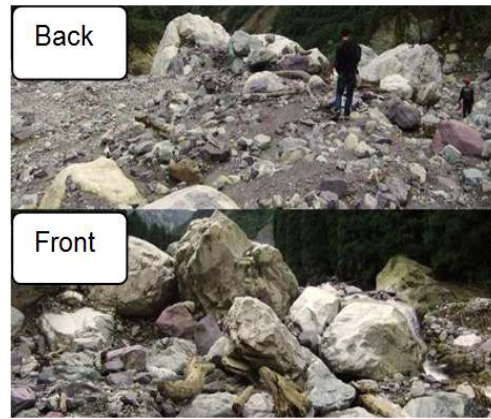
Fig. 12. New natural dam and silting behind the dam in Dagan gully

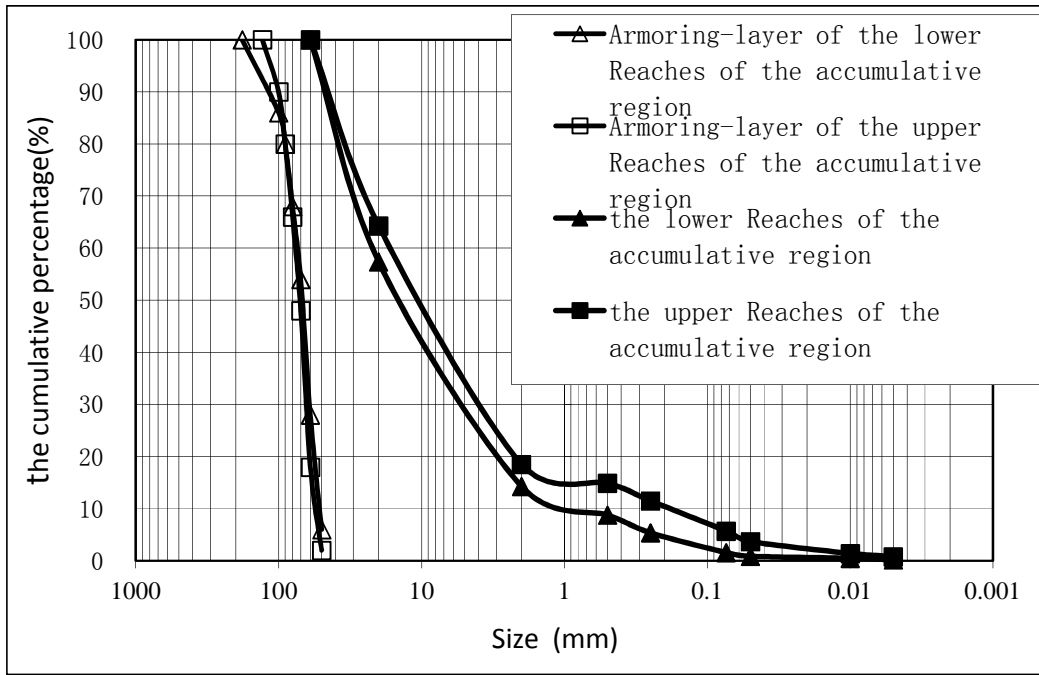
sizes, which shows sub-viscous debris flow. According to the sampling (small sample) in deposition area of debris flow on August 13, the density of debris flow can be calculated on the basis of the particle distribution (shown in Table 1, Fig. 13) of the debris flow deposit [6]:

Fig. 13. Particle distributions of the sediment of the accumulative region
