# Preliminary Study of Nondestructive Testing of the Polymer Cutoff Wall Based on Vibration Theory

The polymer cutoff wall offers the benefits of causing little disturbance to the dam body, being convenient and economical to construct and practical to use, and possessing good resistance to seismic shocks and cracks. It has been widely used to prevent seepage and to reinforce dikes and dams. However, the polymer cutoff wall is a concealed underground structure, and nondestructive testing methods to ensure its integrity are not yet mature. This paper describes a modal analysis of polymer cutoff wall models with different damage scenarios to investigate the feasibility of nondestructive testing of the polymer cutoff wall based on vibration theory. The dynamic characteristics of the first three natural frequencies of the wall and their mode shapes show that horizontal direction damage and centrally located partial damage have a noticeable impact on the dynamic characteristics of the wall, indicating that nondestructive testing based on vibration theory is useful to test for horizontal damage and moderate damage located centrally in the wall.

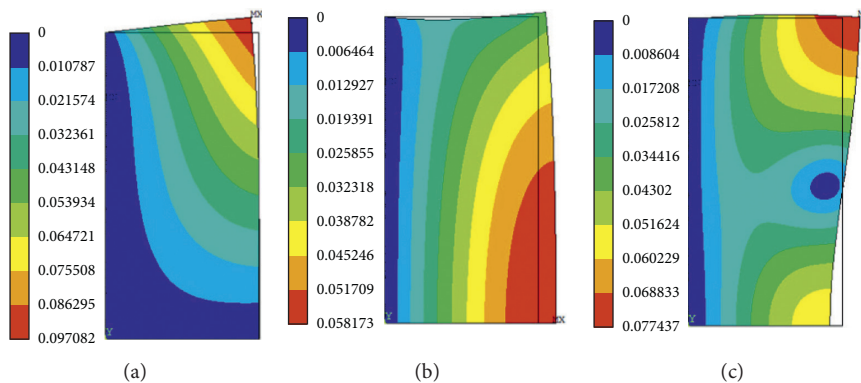
FIGURE 3: Shapes of the first three modes of the moderately horizontally damaged polymer cutoff wall. (a) First vibration mode. (b) Second vibration mode. (c) Third vibration mode.

**2.2.2. Horizontal Damage to Polymer Cutoff Wall.** For slight damage to the polymer cutoff wall in a horizontal direction, we supposed that the polymer cutoff wall had separated at a distance of 1 m from the boundary. In this scenario, the horizontal length of the polymer cutoff wall  $L_1 = 9$  m. There were 254 710 units and 85 705 nodes in the model. Equation (1) gave an equivalent stiffness of the soil surrounding the intact impermeable polymer wall as  $K = 4.10303$  GN/m. For moderate damage to the wall, we supposed that it had separated at a distance of  $L_0/4$  m from the boundary and that the length of the damaged polymer cutoff wall  $L_2 = 7.5$  m. There were 206 381 units and 69 549 nodes in the model. Equation (1) gave an equivalent stiffness of the soil surrounding the intact impermeable polymer wall as  $K = 4.1003$  GN/m. Because the entire wall was broken, the fracture surface was no longer constrained by adjacent wall sections. In the two horizontal damage cases, modal analysis gave the first three natural frequencies of the horizontally damaged polymer cutoff wall that are shown in Table 2; the first three natural frequency modes are shown in Figure 2 and Figure 3.

Table 2 shows that, for the polymer cutoff wall that was damaged horizontally, the first three natural frequencies differed greatly from those for the intact wall. In the case of mild damage, the first three natural frequencies decreased, respectively, by 38%, 44%, and 40%. In the case of moderate damage, the respective decreases were 30%, 44%, and 40%. A comparison of Figures 2 and 3 with Figure 1 clearly shows that there was a great change in the horizontally damaged wall. Therefore, any one of the first three modes can be used to determine the integrity of a polymer cutoff wall with damage in the horizontal direction.
